Project No. 4063.002.024

Subject: Wendt Ranch, Monterosso, and Mustang Soccer Fields  
Wendt Ranch Geologic Hazard Abatement District  
Contra Costa County, California

**GEOLOGIC HAZARD ABATEMENT DISTRICT MONITORING  
FALL 2024**

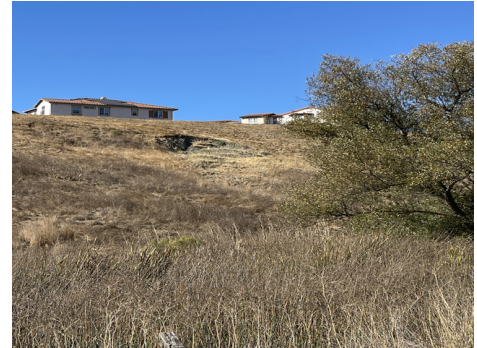
During heavy rainfall monitoring in January 2023, mobilization of multiple surficial landslides was observed on the slope east of Genoa Court (Figure 1, Site Condition A.1). At the time, there were two landslides: one that measured approximately 80 feet in width, 65 feet in length, and head scarp approximately 2 feet in height, which is now revegetated; and landslide A.1, which measured approximately 40 feet in width, 65 feet in length, and head scarp of approximately 3 feet

in height. During the fall 2024 monitoring event, we observed that landslide A.1 appeared to be revegetating but continues to creep exposing a slowly widening head scarp. We will continue to monitor this area.

Site Condition: A.1  
Observation Date: 10/24/2024  
Description: Shallow landslide on slope southeast of Genoa Court.  
Recommendation: Continue to monitor.  
Field Representative: MJ

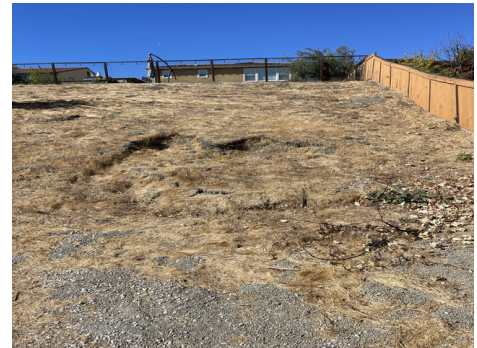
We noted during our fall 2024 monitoring that a shallow landslide was located on the slope between Bengali Court and Enderby Street and above an access trail (Figure 2, Site Condition A.2). The failure does not appear to be impacting nearby improvements at this time and we will continue to monitor the slope.

Site Condition: A.2  
Observation Date: 10/24/2024  
Description: Shallow landslide on slope above access trail.  
Recommendation: Continue to monitor.  
Field Representative: MJ

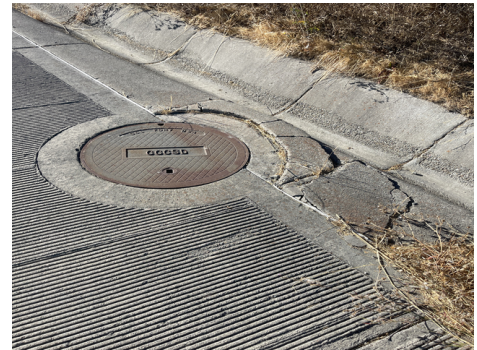
Site Condition: B.1  
Observation Date: 10/24/2024  
Description: Cracking of concrete around manhole.  
Recommendation: Continue to monitor.  
Field Representative: MJ

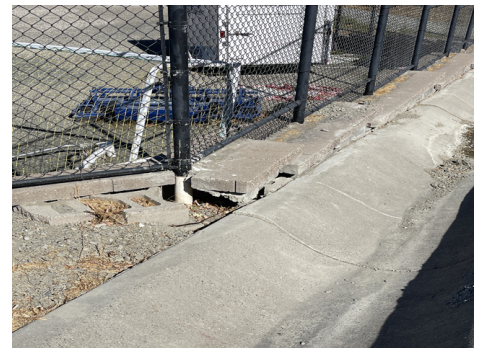
We noted during our fall 2023 monitoring event that the soil between the concrete-lined drainage ditch and the block retaining wall on the southeastern corner of the Mustang Soccer fields was eroded, and created voids and settlement of the upper blocks of the retaining wall (Figure 1, Site Condition C.1). We recommend backfilling the voids and repairing the displaced wall blocks to prevent distress to the wall and nearby ditch.

Site Condition: C.1  
Observation Date: 10/24/2024  
Description: Erosion along concrete-lined drainage ditch behind retaining block wall.  
Recommendation: Backfill eroded area and repair displaced blocks.  
Field Representative: MJ

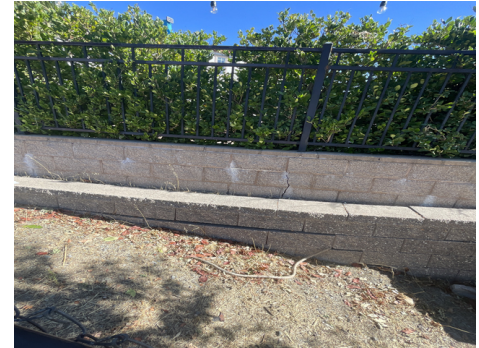
We previously noted a 1-inch vertical gap between the upper and lower blocks and between the adjacent blocks in the western portion of the rear retaining wall at 217 Monterosso Court (Figure 1, Site Condition C.2). It appeared that localized loading from the upper concrete masonry unit (CMU) block retaining wall caused displacement of portions of the lower mechanically stabilized earth retaining wall. In addition, water staining was found on the CMU wall and water might have been seeping through the CMU wall. It appeared that drainage of the upper CMU wall may not be sufficient to capture stormwater runoff and/or irrigation water. Saturated backfill soil may further impact the lower wall. During our most recent monitoring event, we noted this condition had not changed. The GHAD will continue to monitor the CMU block wall during scheduled monitoring events although the conditions causing the crack appear to be localized.

Site Condition: C.2  
Observation Date: 10/24/2024  
Description: Up to 1-inch gap and cracking in rear mechanically stabilized earth retaining wall at 217 Monterosso Court.  
Recommendation: Continue to monitor.  
Field Representative: MJ

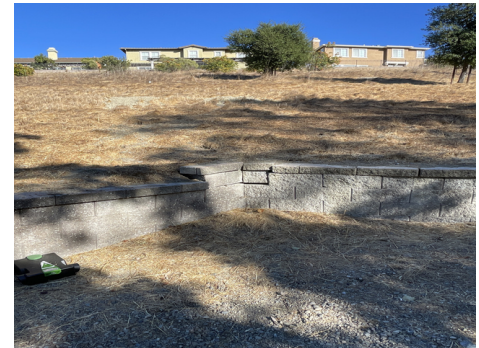
During our spring 2024 monitoring event, we noted distress to the block retaining wall at the base of the slope along the western perimeter of the site (Figure 1, Site Condition C.3).

Site Condition: C.3  
Observation Date: 10/24/2024  
Description: Settlement and offset of masonry blocks in retaining wall at base of slope.  
Recommendation: Continue to monitor wall and slope.  
Field Representative: MJ

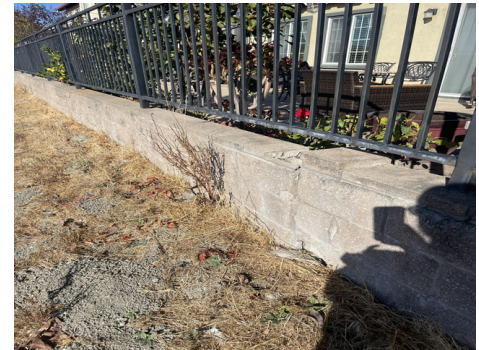
We continued to note a crack up to ¼ inch in width that was observed extending from the top of the wall to the bottom of the wall at a 3-foot-high masonry wall behind 1560 Colchester Street (Figure 1, Site Condition C.4). The crack was observed located adjacent to an expansion joint. It appeared that the crack was caused by additional loading of the masonry wall from planters and a fountain constructed on the uphill side of the wall. The GHAD notified the homeowner of this condition in February 2020 and requested that the planter and fountain be relocated. During our most recent monitoring event, we noted that this condition remained unchanged. We will continue to monitor the masonry wall condition during scheduled monitoring events, although the conditions causing the crack appeared to be localized.

Site Condition: C.4  
Observation Date: 10/24/2024  
Description: Cracking on block retaining wall.  
Recommendation: Continue to monitor.  
Field Representative: MJ

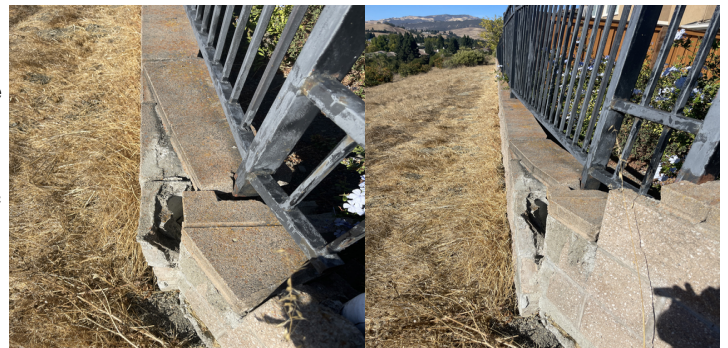
We noted during our spring 2021 monitoring that there is distress and offset along the 3-foot-high masonry wall behind 1608 Colchester Street (Figure 1, Site Condition C.5). In addition, it appeared that the wall embedment was exposed and the crushed rock leveling pad of the wall was displayed, which were probably due to animal burrowing. During our most recent monitoring event, we noted this condition had not changed. The GHAD will continue to monitor the distress and consider placing engineered fill to provide design wall embedment.

Site Condition: C.5  
Observation Date: 10/24/2024  
Description: Offset and separation in block retaining wall due to loading by planter bed inside lot.  
Recommendation: Continue to monitor distress and consider placement of engineered backfill to re-establish design wall embedment.  
Field Representative: MJ

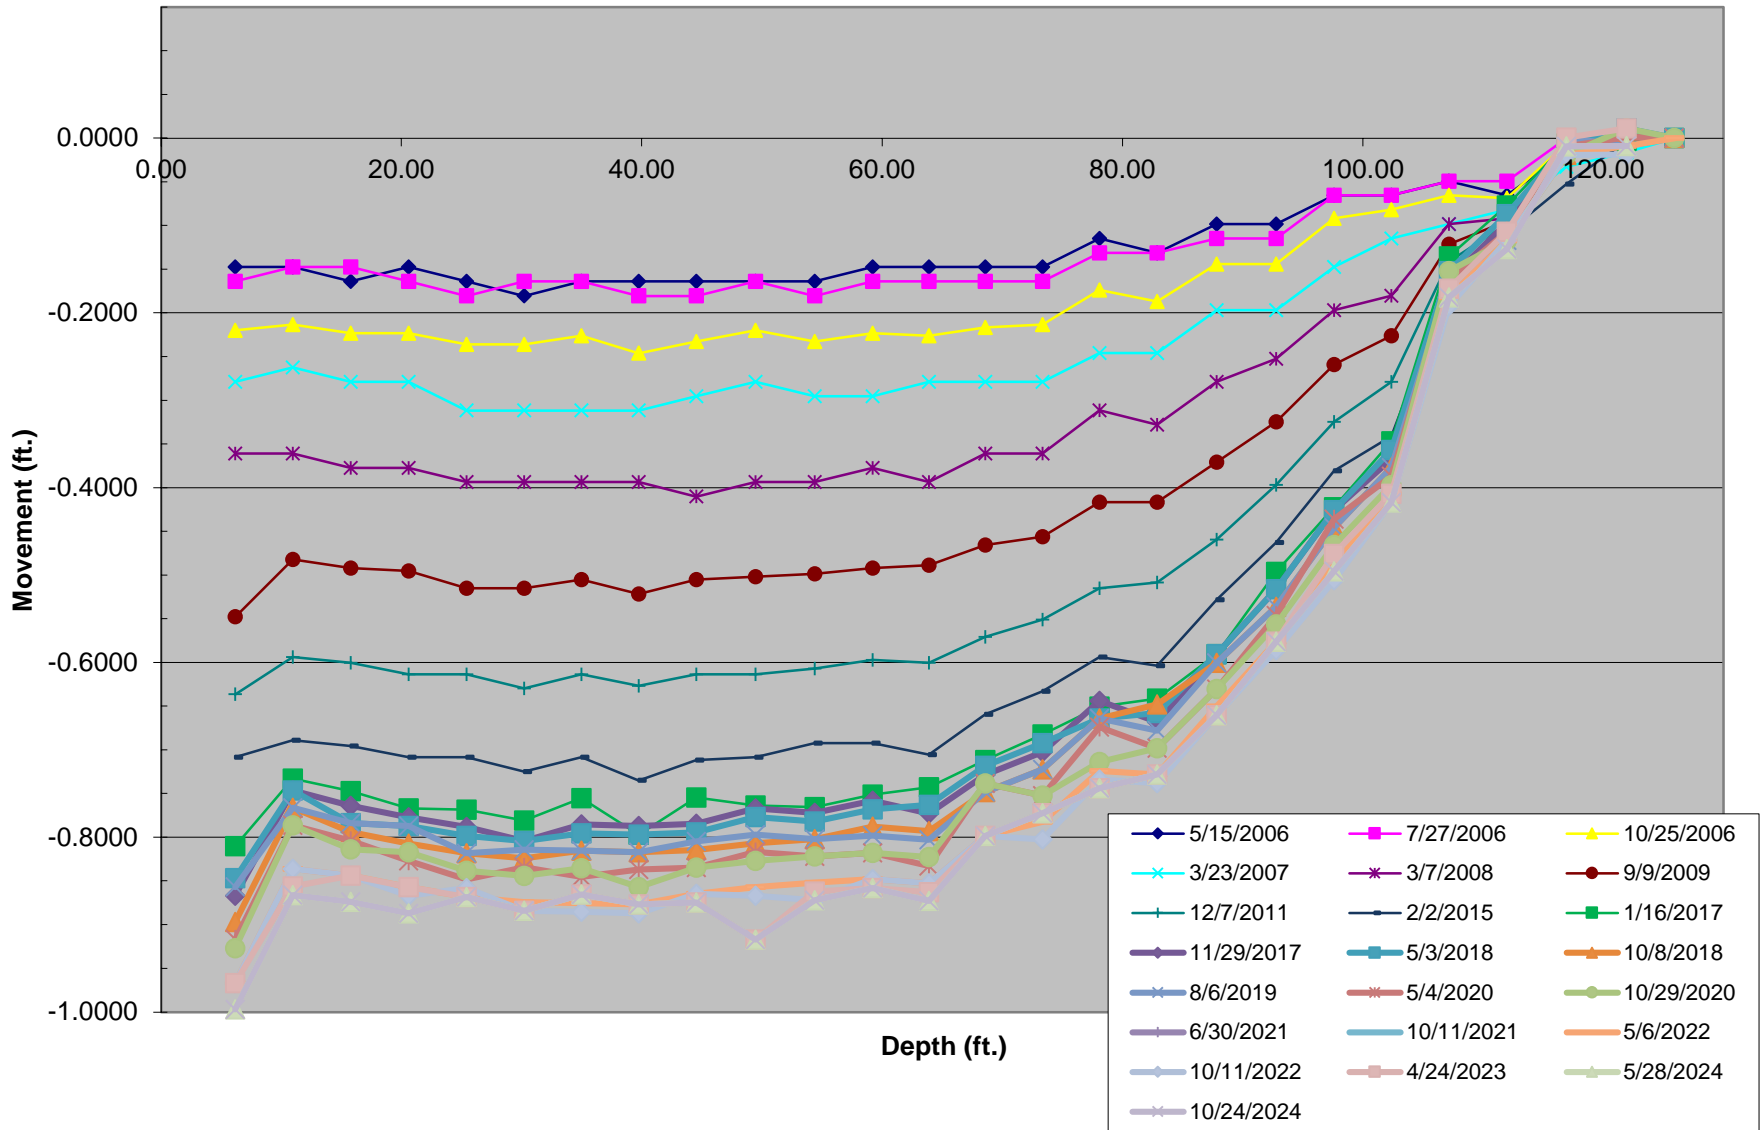
**FIGURE 4: Intervening Properties Settlement Monitoring**

Since the time of the last monitoring event on May 28, 2024, no movement was measured. As expected, it appears that the rate of settlement is decreasing and is near completion. Some additional minor movement of the engineered fill may be expected during progressive wetting of the fill material. We expect this wetting is occurring in large part due to rainfall and landscape irrigation. A graph that includes the most recent monitoring event for the settlement monument is provided as an attachment to this report (Figure 4).

Minor movement, as depicted in Figure 4, was observed on the upper 10 feet of the engineered fill since 2009. Lateral fill stretching or lateral fill extension of a compacted fill slope is a phenomenon that is related to lateral movement of the upper zone of expansive compacted soil due to wetting and drying. The shallow depth of the expansive fill located on top of a downhill fill slope will experience swelling/expanding upward and also swelling laterally due to wetting. The magnitude of the lateral fill extension at the top of the downhill slope depends on the expansiveness of the fill materials, fill thickness, fill slope gradient, and the extent of wetting. Based on the site clayey fill material, the slope inclination, and fill thickness, it is our opinion that the minor movement of the upper 10 feet of fill, as shown in Figure 4, is due to lateral extension of the fill slope. The GHAD will continue monitoring the fill extension at this fill slope.
