Project No. **4063.002.025**

Subject: Wendt Ranch, Monterosso, and Mustang Soccer Fields  
Wendt Ranch Geologic Hazard Abatement District  
Contra Costa County, California

**GEOLOGIC HAZARD ABATEMENT DISTRICT MONITORING  
FALL 2025**

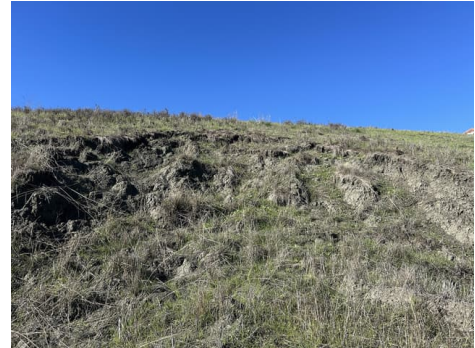
During the winter of 2016/2017, an existing landslide was reactivated on the slope below Genoa Court (Figure 1). At the time, the landslide was measured approximately 50 feet in width and 165 feet in length, terminating near the creek. The head scarp was measured approximately 7 feet in height and exposed engineered fill. Based on our 2017 field observations, it appeared that this landslide may be approximately 10 to 15 feet in depth. From a review of the as-built geotechnical corrective grading plan, it appeared that the landslide is located immediately below the graded portion of the slope, and in 2017, it did not have the potential to impact site improvements. During the fall 2021 monitoring event, additional movement of this slide was noted with similar dimensions that we observed in 2017. During heavy rainfall monitoring in January 2023, additional movement of the landslide was noted. The landslide scarp extended approximately 10 feet upslope and approximately 10 feet laterally. The movement did not appear to be of any immediate concern, and the GHAD continues monitoring the landslide and would consider repairs if significant additional movement was identified during future monitoring events. During the fall

2023 monitoring event, we observed that the failed area appeared to be revegetating well and had not experienced significant additional movement. During this monitoring event, we observed evidence of recent slope movement although the slope failure appeared mostly unchanged in dimension (Site Conditions A.1, Appendix A, Figure 1). The GHAD will continue to monitor the failed area and note in future monitoring reports if any changes are observed.

Site Condition: A.1  
Observation Date: 10/23/2025  
Description: Surficial landslide on slope east of Genoa Court.  
Recommendation: Continue to monitor.  
Field Representative: EW

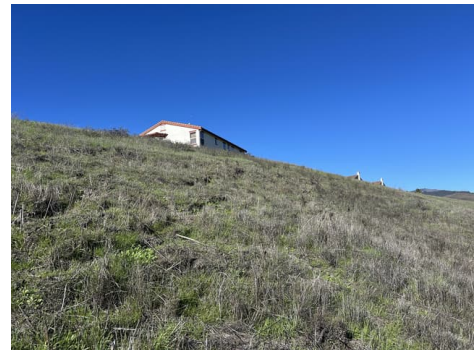
In addition, during heavy rainfall monitoring in January 2023, mobilization of multiple surficial landslides was observed on the downhill slope east of Genoa Court (Site Conditions A.2 and A.3, Appendix A, Figure 1). At the time, there were two landslides: one that measured approximately 80 feet in width, 65 feet in length, and head scarp approximately 2 feet in height (Site Condition A.2, Appendix A, Figure 1) and a second surficial landslide located approximately 200 feet to the south, which measured approximately 40 feet in width, 65 feet in length, and head scarp approximately 3 feet in height (Site Condition A.3, Appendix A, Figure 1). During this monitoring event, we observed that Landslides A.2 and A.3 appeared to be revegetating but continued to creep and expose a slowly widening head scarp. These landslides are located relatively far away from any improvements; therefore, these landslides currently pose no impact on any improvements nearby. The GHAD will continue to monitor the failed areas and note in future monitoring reports if any changes are observed.

Site Condition: A.2  
Observation Date: 10/23/2025  
Description: Shallow surficial landslide on slope northeast of Genoa Court.  
Recommendation: Continue to monitor.  
Field Representative: EW

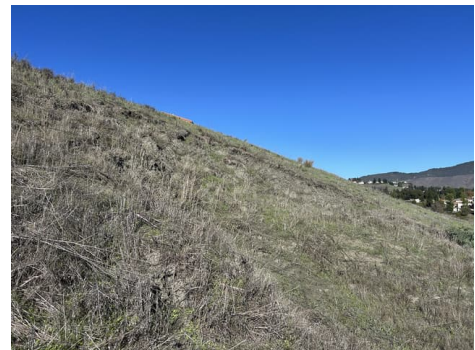
Site Condition: A.3  
Observation Date: 10/23/2025  
Description: Shallow surficial landslide on slope southeast of Genoa Court. Appears to be mostly vegetated.  
Recommendation: Continue to monitor.  
Field Representative: EW

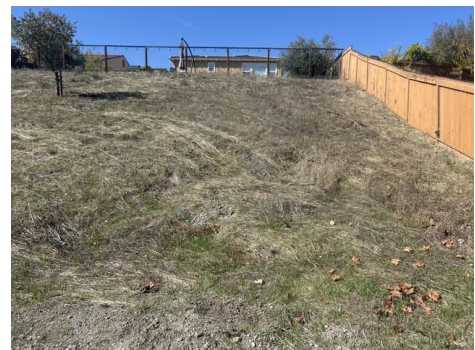
During our fall 2024 monitoring event, a shallow landslide was observed located above an access trail on the slope between Bengali Court and Enderby Street (Site Condition A.4, Appendix A, Figure 2). During our most recent monitoring event, the slope appeared to be fully vegetated. The GHAD will continue to monitor the condition of the slope during future monitoring events.

Site Condition: A.4  
Observation Date: 10/23/2025  
Description: Shallow surficial landslide on slope above access trail. Appears to be fully vegetated.  
Recommendation: Continue to monitor.  
Field Representative: EW

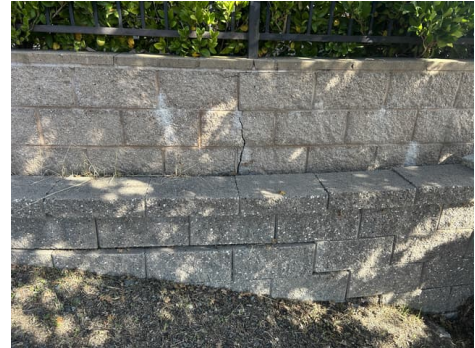
As first noted in the spring 2019 monitoring report, we continued to observe a gap between the upper and lower blocks and between the adjacent blocks in the western portion of the rear retaining wall at 217 Monterosso Court. During our most recent monitoring event, we observed that the distress appeared in similar condition from our spring 2025 monitoring event, with a maximum gap of approximately 1¼ inches (Site Condition B.1, Appendix A, Figure 1). It appeared that localized loading from the upper mechanically stabilized earth (MSE) retaining wall caused displacement of portions of the lower mechanically stabilized earth retaining wall. In addition, water staining was found on the MSE wall and water might have been seeping through the MSE wall. It appeared that drainage of the upper MSE wall may not be sufficient to capture stormwater runoff and/or irrigation water. Saturated backfill soil may further impact the lower wall. The GHAD will continue to monitor the MSE block wall during scheduled monitoring events although the conditions causing the crack appear to be localized.

Site Condition: B.1  
Observation Date: 10/23/2025  
Description: Distress in MSE retaining wall with gaps measuring up to approximately 1 and 1/4 inch.  
Recommendation: Continue to monitor.  
Field Representative: EW

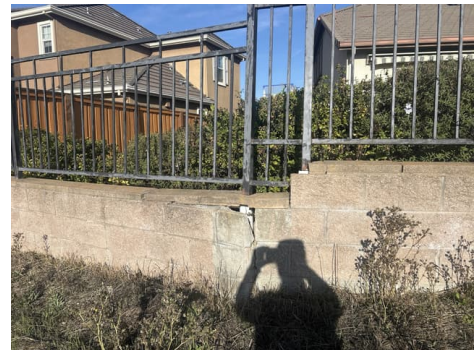
As first reported in the fall 2021 monitoring event, we observed distress and offset along the 3-foot-high masonry wall behind 1608 Colchester Street (Site Condition B.2, Appendix A, Figure 1). During our most recent monitoring event, we observed that the condition of the retaining

structure remained unchanged since the spring 2025 monitoring event. The GHAD will continue to monitor the distress and consider placing engineered fill to provide design wall embedment.

Site Condition: B.2  
Observation Date: 10/23/2025  
Description: Offset and separation in block retaining wall due to loading by planter bed inside lot.  
Recommendation: Continue to monitor.  
Field Representative: EW

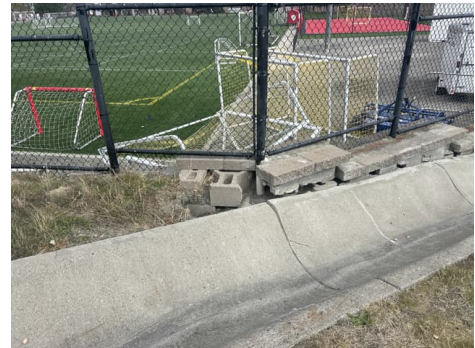
During our fall 2023 monitoring event, we observed erosion behind the MSE retaining wall on the southeastern boundary of the Mustang Soccer League fields (Site Condition B.3, Appendix A, Figure 2). The GHAD will continue to monitor this condition and consider placing engineered fill to provide design wall backfill height.

Site Condition: B.3  
Observation Date: 10/23/2025  
Description: Erosion behind MSE wall on the southeastern boundary of the Mustang Soccer League fields.  
Recommendation: Continue to monitor.  
Field Representative: EW

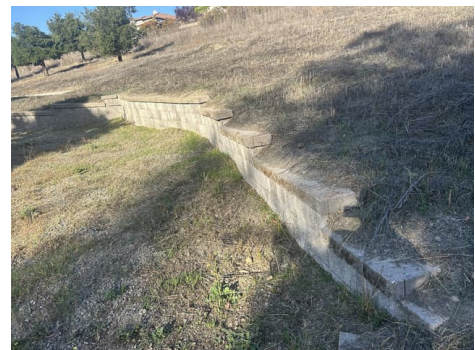
We first noted the distress of a masonry block retaining wall located at the base of the uphill slope along the western perimeter of the site during our spring 2024 monitoring event. During our fall 2025 monitoring event, we continued to observe settlement and offset of masonry blocks of the retaining wall and observed that the southern end of the retaining wall is leaning downslope at an angle of approximately 20 degrees (Site Condition B.4, Appendix A, Figure 1). The GHAD will continue to monitor this condition in future events.

Site Condition: B.4  
Observation Date: 10/23/2025  
Description: Distress in retaining wall at base of slope west of Colchester Street.  
Recommendation: Continue to monitor.  
Field Representative: EW

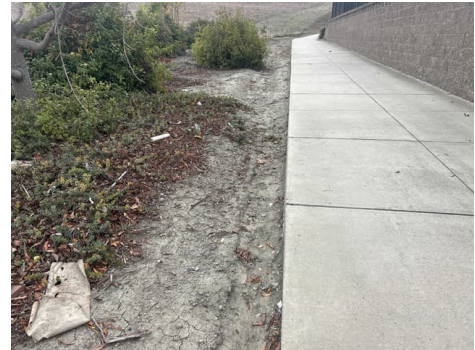
During the fall 2025 monitoring event, we observed a minor erosional rill in the landscaped area on the east side of the pedestrian pathway and northeast of the Mustang Soccer League fields (Site Condition C, Appendix A, Figure 2). The GHAD will continue to monitor this condition in future events.

Site Condition: C  
Observation Date: 10/23/2025  
Description: Erosional rill in the landscaped area on the east side of the pedestrian pathway to the northeast of the Mustang League Soccer fields.  
Recommendation: Continue to monitor.  
Field Representative: EW

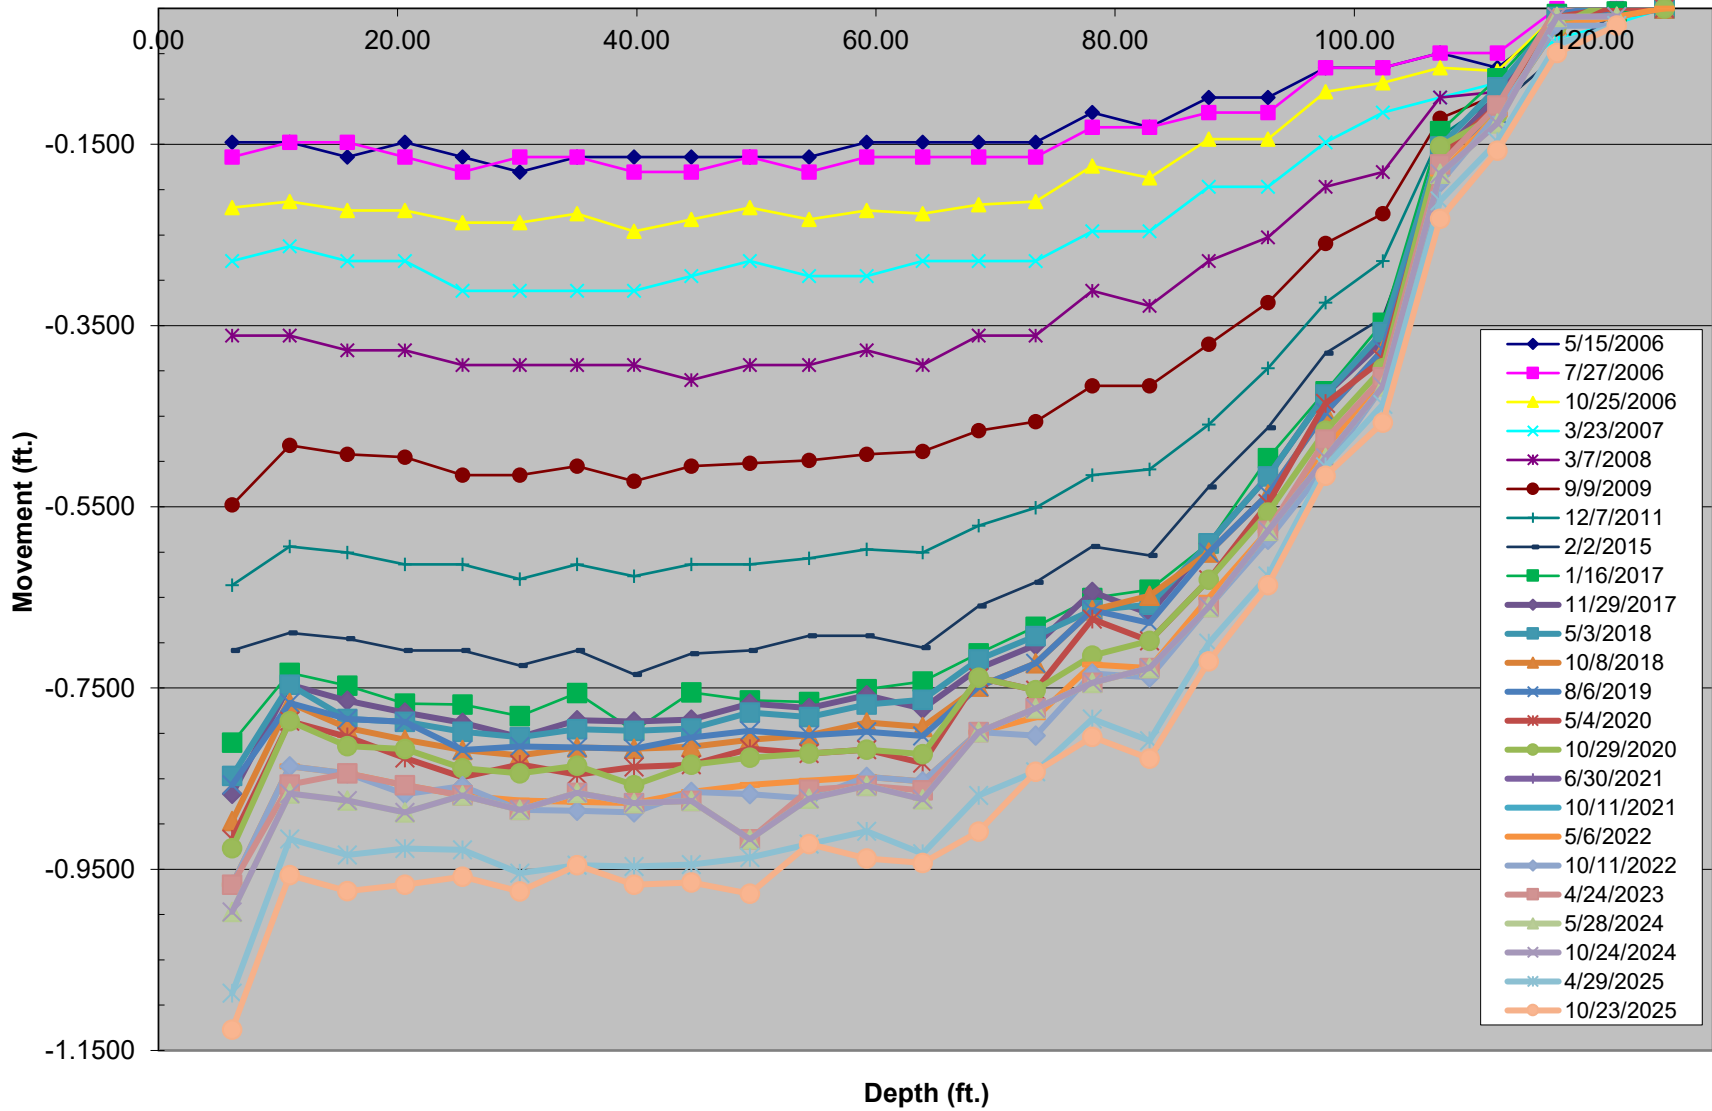
**FIGURE 4: Intervening Properties Settlement Monitoring**

Since the time of the last monitoring event on April 29, 2025, consistent and minor movement was measured. As expected, it appears that the rate of settlement is decreasing and is near completion. Some additional minor movement of the engineered fill may be expected during progressive wetting of the fill material. We expect this wetting is occurring in large part due to rainfall and landscape irrigation. A graph that includes the most recent monitoring event for the settlement monument is provided as an attachment to this report (Figure 4).

Minor movement, as depicted in Figure 4, was observed on the upper 10 feet of the engineered fill since 2009. Lateral fill stretching or lateral fill extension of a compacted fill slope is a phenomenon that is related to lateral movement of the upper zone of expansive compacted soil due to wetting and drying. The shallow depth of the expansive fill located on top of a downhill fill slope will experience swelling/expanding upward and also swelling laterally due to wetting. The magnitude of the lateral fill extension at the top of the downhill slope depends on the expansiveness of the fill materials, fill thickness, fill slope gradient, and the extent of wetting. Based on the site clayey fill material, the slope inclination, and fill thickness, it is our opinion that the minor movement of the upper 10 feet of fill, as shown in Figure 4, is due to lateral extension of the fill slope. The GHAD will continue monitoring the fill extension at this fill slope.
