Project No. 4063.002.024

Subject: Wendt Ranch, Monterosso, and Mustang Soccer Fields  
Wendt Ranch Geologic Hazard Abatement District  
Contra Costa County, California

**GEOLOGIC HAZARD ABATEMENT DISTRICT MONITORING  
FALL 2024**

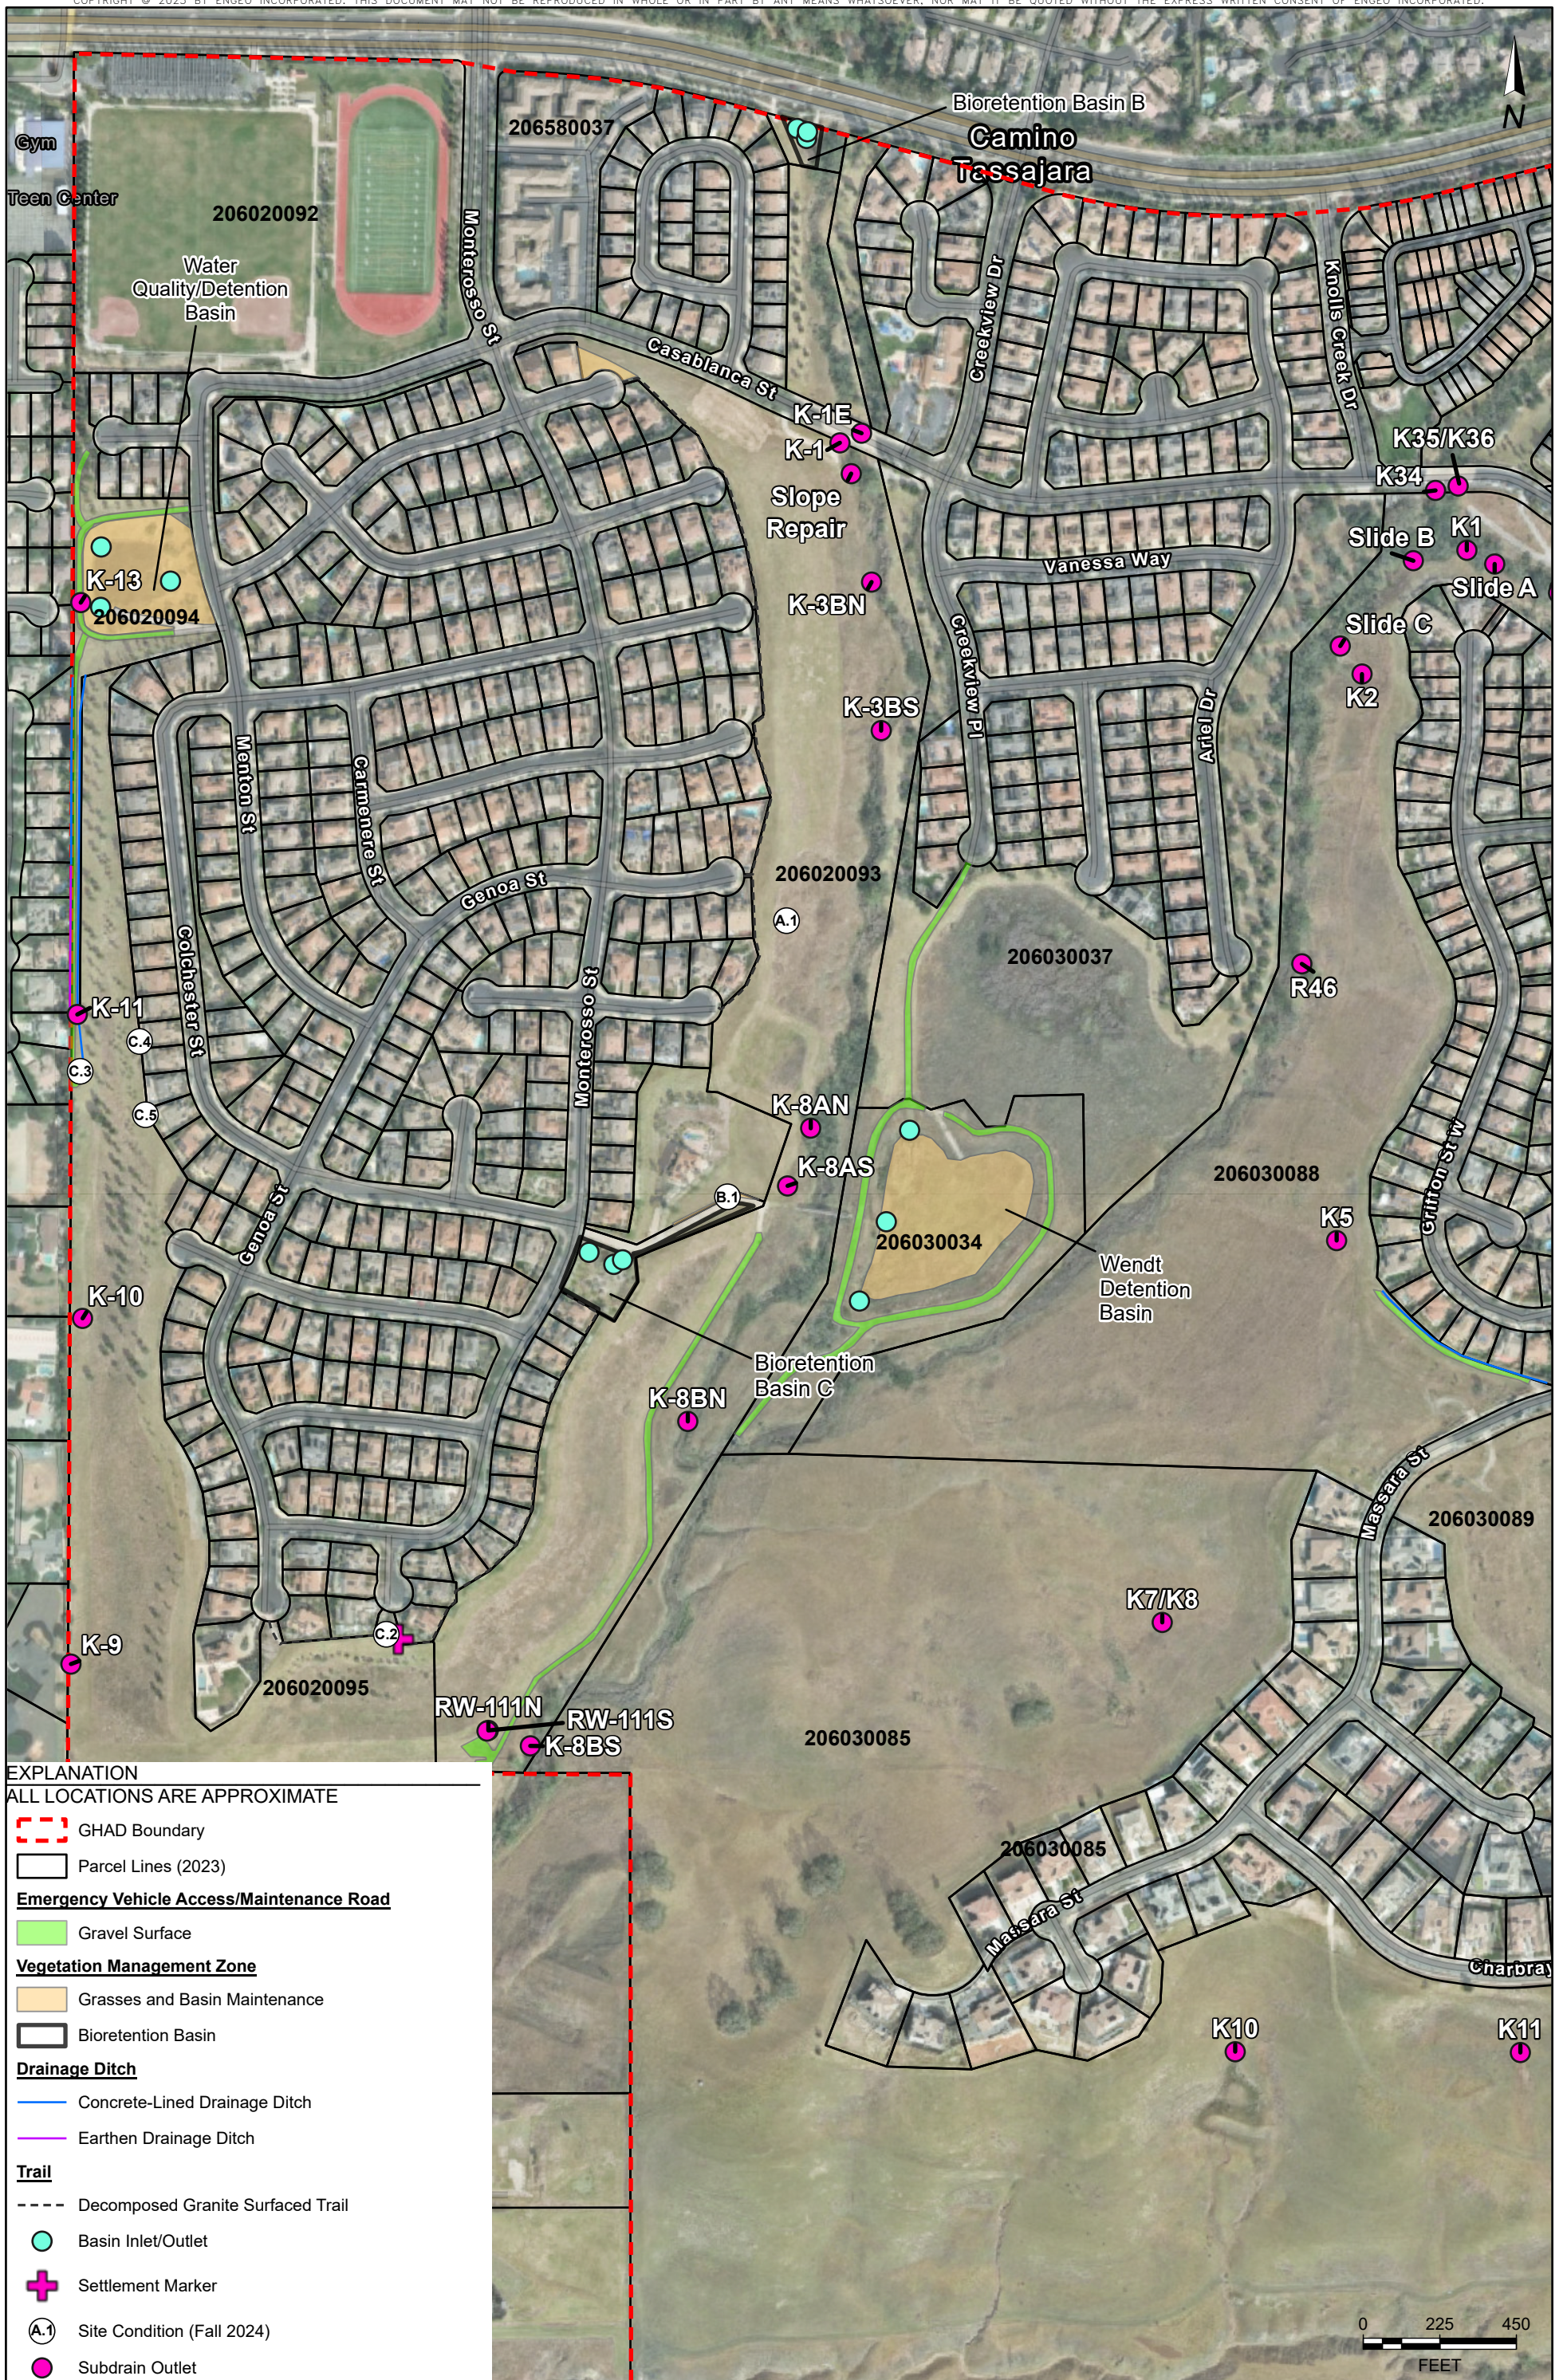
PROJECT NO. : 4063.002.024	FIGURE NO.
SCALE: AS SHOWN	<b>1</b>
DRAWN BY: NWC	CHECKED BY: MT

We continued to note a crack up to ¼ inch in width that was observed extending from the top of the wall to the bottom of the wall at a 3-foot-high masonry wall behind 1560 Colchester Street (Figure 1, Site Condition C.4). The crack was observed located adjacent to an expansion joint. It appeared that the crack was caused by additional loading of the masonry wall from planters and a fountain constructed on the uphill side of the wall. The GHAD notified the homeowner of this condition in February 2020 and requested that the planter and fountain be relocated. During our most recent monitoring event, we noted that this condition remained unchanged. We will continue to monitor the masonry wall condition during scheduled monitoring events, although the conditions causing the crack appeared to be localized.

We noted during our spring 2021 monitoring that there is distress and offset along the 3-foot-high masonry wall behind 1608 Colchester Street (Figure 1, Site Condition C.5). In addition, it appeared that the wall embedment was exposed and the crushed rock leveling pad of the wall was displayed, which were probably due to animal burrowing. During our most recent monitoring event, we noted this condition had not changed. The GHAD will continue to monitor the distress and consider placing engineered fill to provide design wall embedment.

We previously noted a 1-inch vertical gap between the upper and lower blocks and between the adjacent blocks in the western portion of the rear retaining wall at 217 Monterosso Court (Figure 1, Site Condition C.2). It appeared that localized loading from the upper concrete masonry unit (CMU) block retaining wall caused displacement of portions of the lower mechanically stabilized earth retaining wall. In addition, water staining was found on the CMU wall and water might have been seeping through the CMU wall. It appeared that drainage of the upper CMU wall may not be sufficient to capture stormwater runoff and/or irrigation water. Saturated backfill soil may further impact the lower wall. During our most recent monitoring event, we noted this condition had not changed. The GHAD will continue to monitor the CMU block wall during scheduled monitoring events although the conditions causing the crack appear to be localized.

During our spring 2024 monitoring event, we noted distress to the block retaining wall at the base of the slope along the western perimeter of the site (Figure 1, Site Condition C.3).

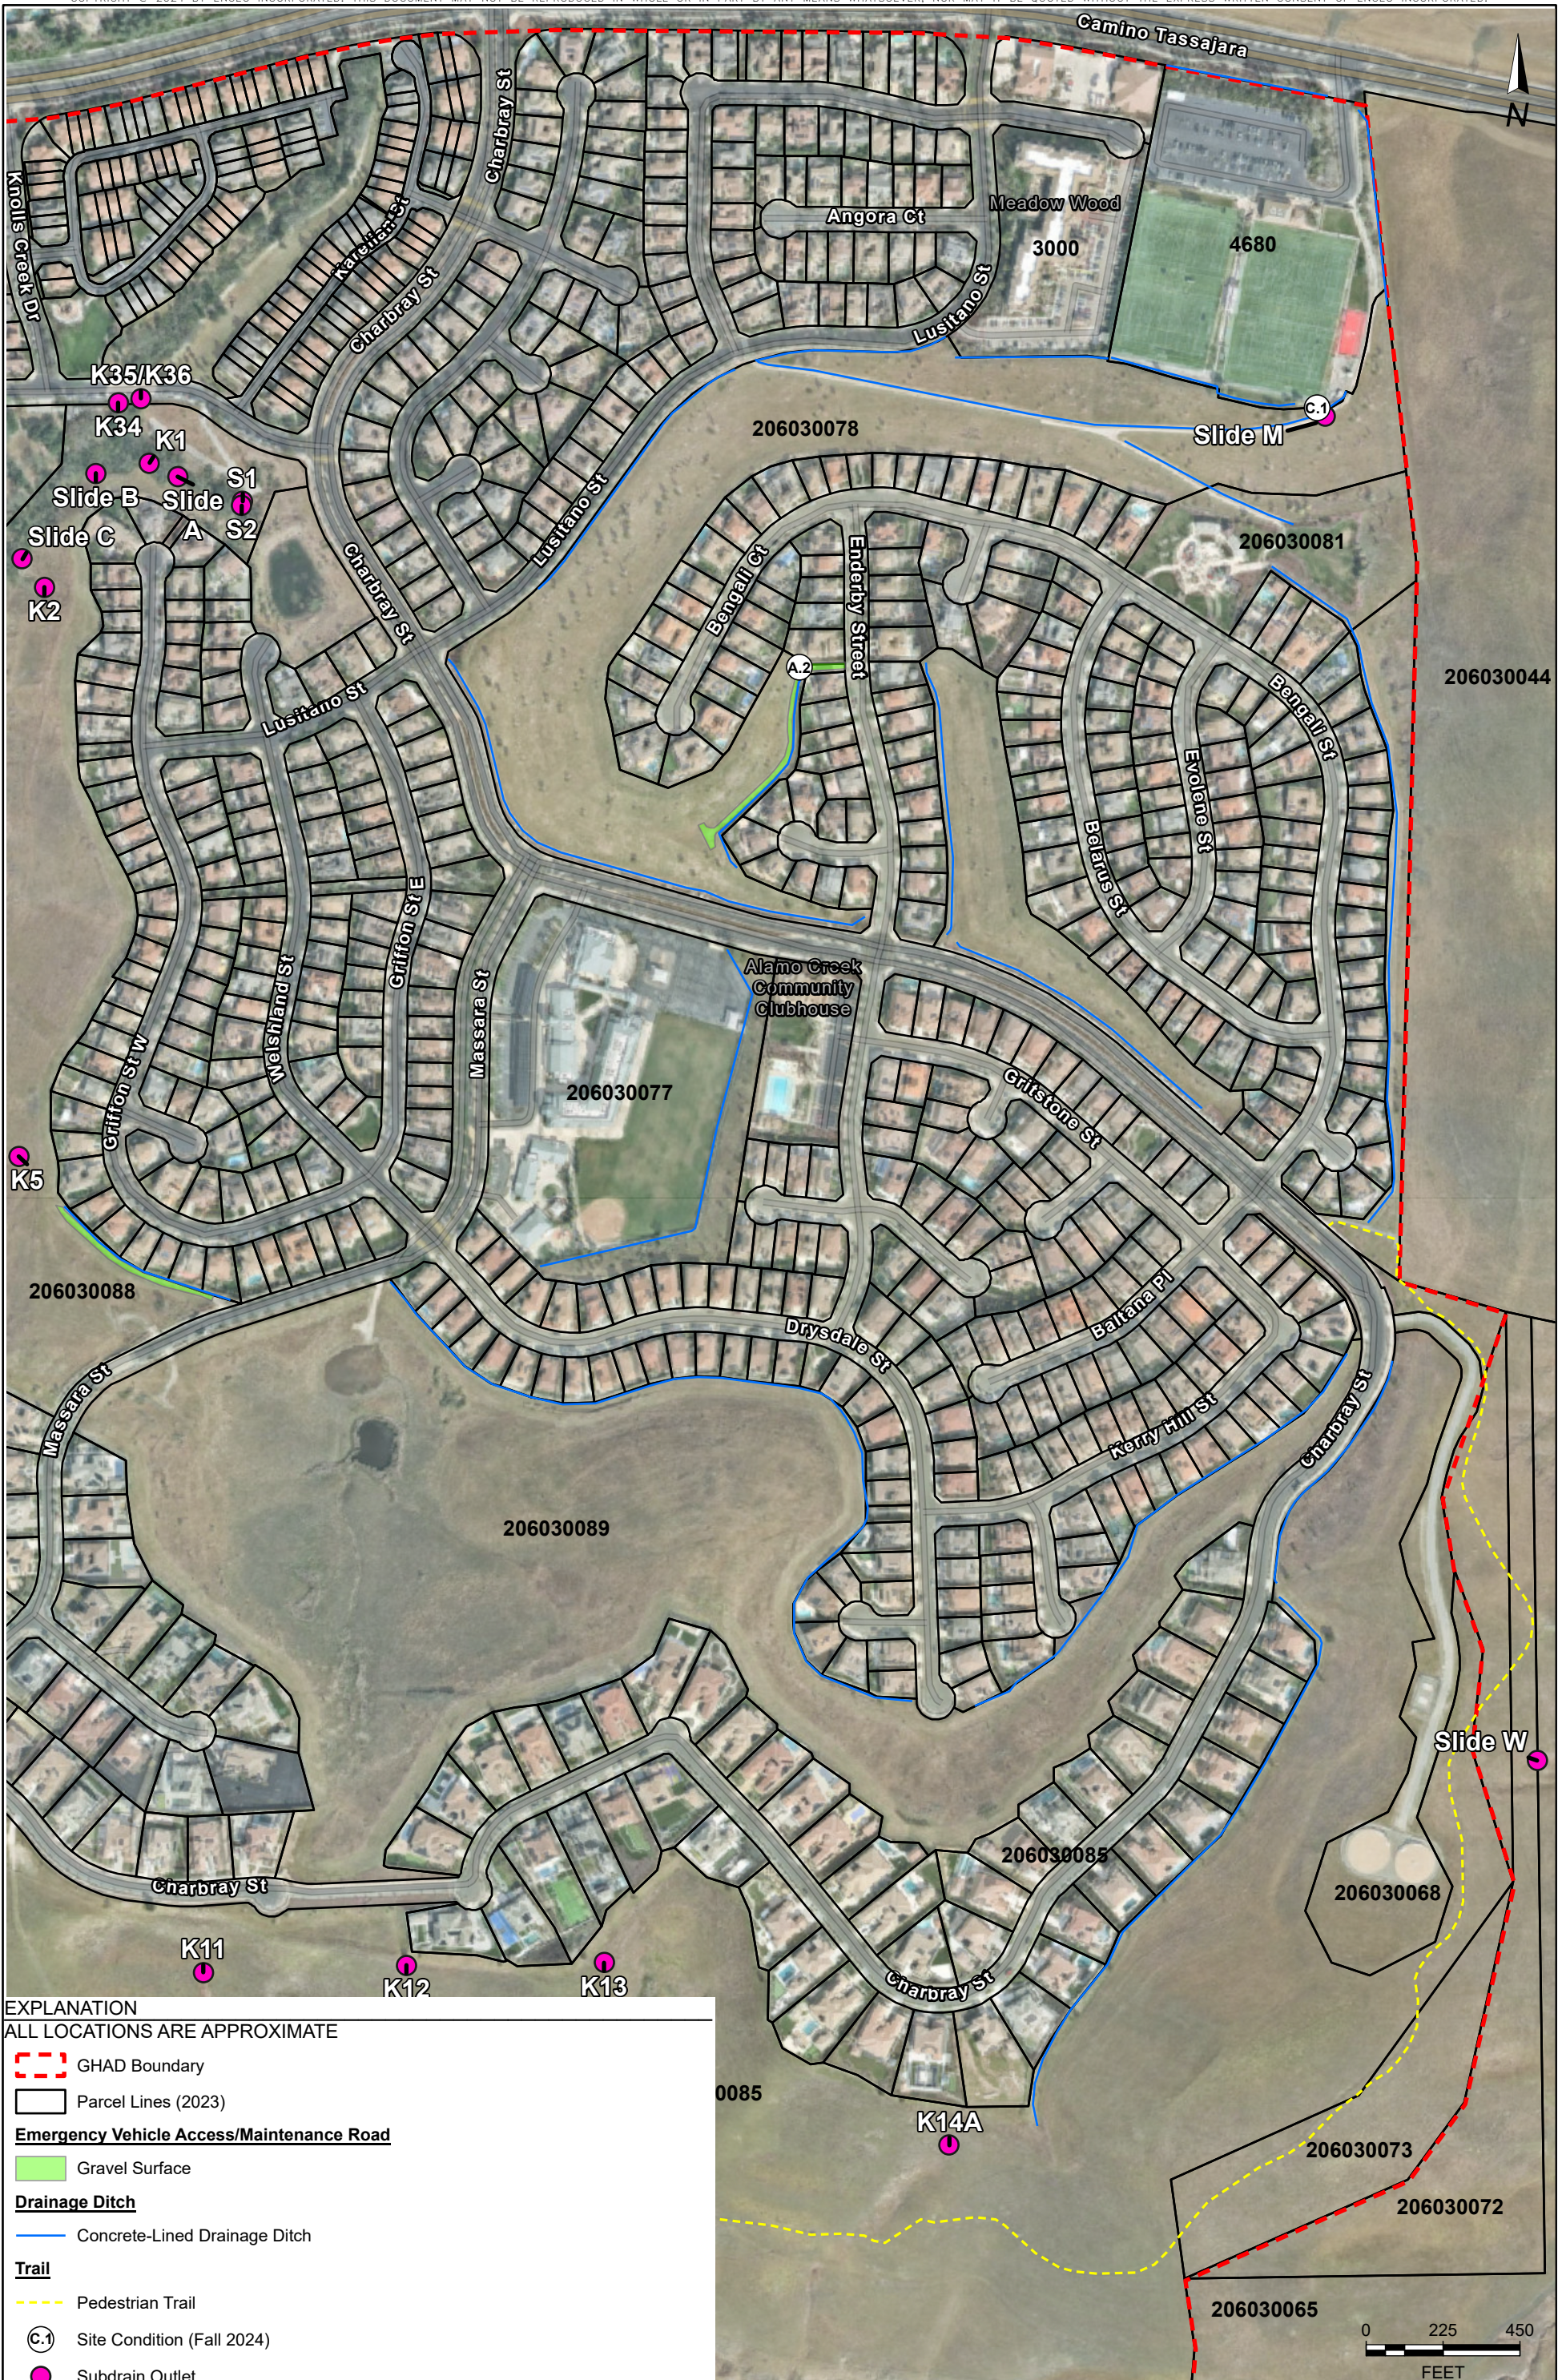
PROJECT NO. : 4063.002.024	FIGURE NO.
SCALE: AS SHOWN	<b>2</b>
DRAWN BY: NWC   CHECKED BY: MT

We noted during our fall 2024 monitoring that a shallow landslide was located on the slope between Bengali Court and Enderby Street and above an access trail (Figure 2, Site Condition A.2). The failure does not appear to be impacting nearby improvements at this time and we will continue to monitor the slope.

During the fall 2021 monitoring event, exposed geogrid and separation fabric were noted at a previously repaired landslide (Figure 2, Slide A), located north of Griffon Court. The engineered slope appeared to be slowly eroding, though underlying native soil remains stable. This erosion is likely due to the angle of the engineered fill overlying the separation fabric. The soil erosion did not appear to be of immediate concern and the GHAD will continue monitoring this condition in the future, once annexed into the GHAD boundary.
