Project No. **4063.002.025**

Subject: Wendt Ranch, Monterosso, and Mustang Soccer Fields  
Wendt Ranch Geologic Hazard Abatement District  
Contra Costa County, California

**GEOLOGIC HAZARD ABATEMENT DISTRICT MONITORING  
FALL 2025**

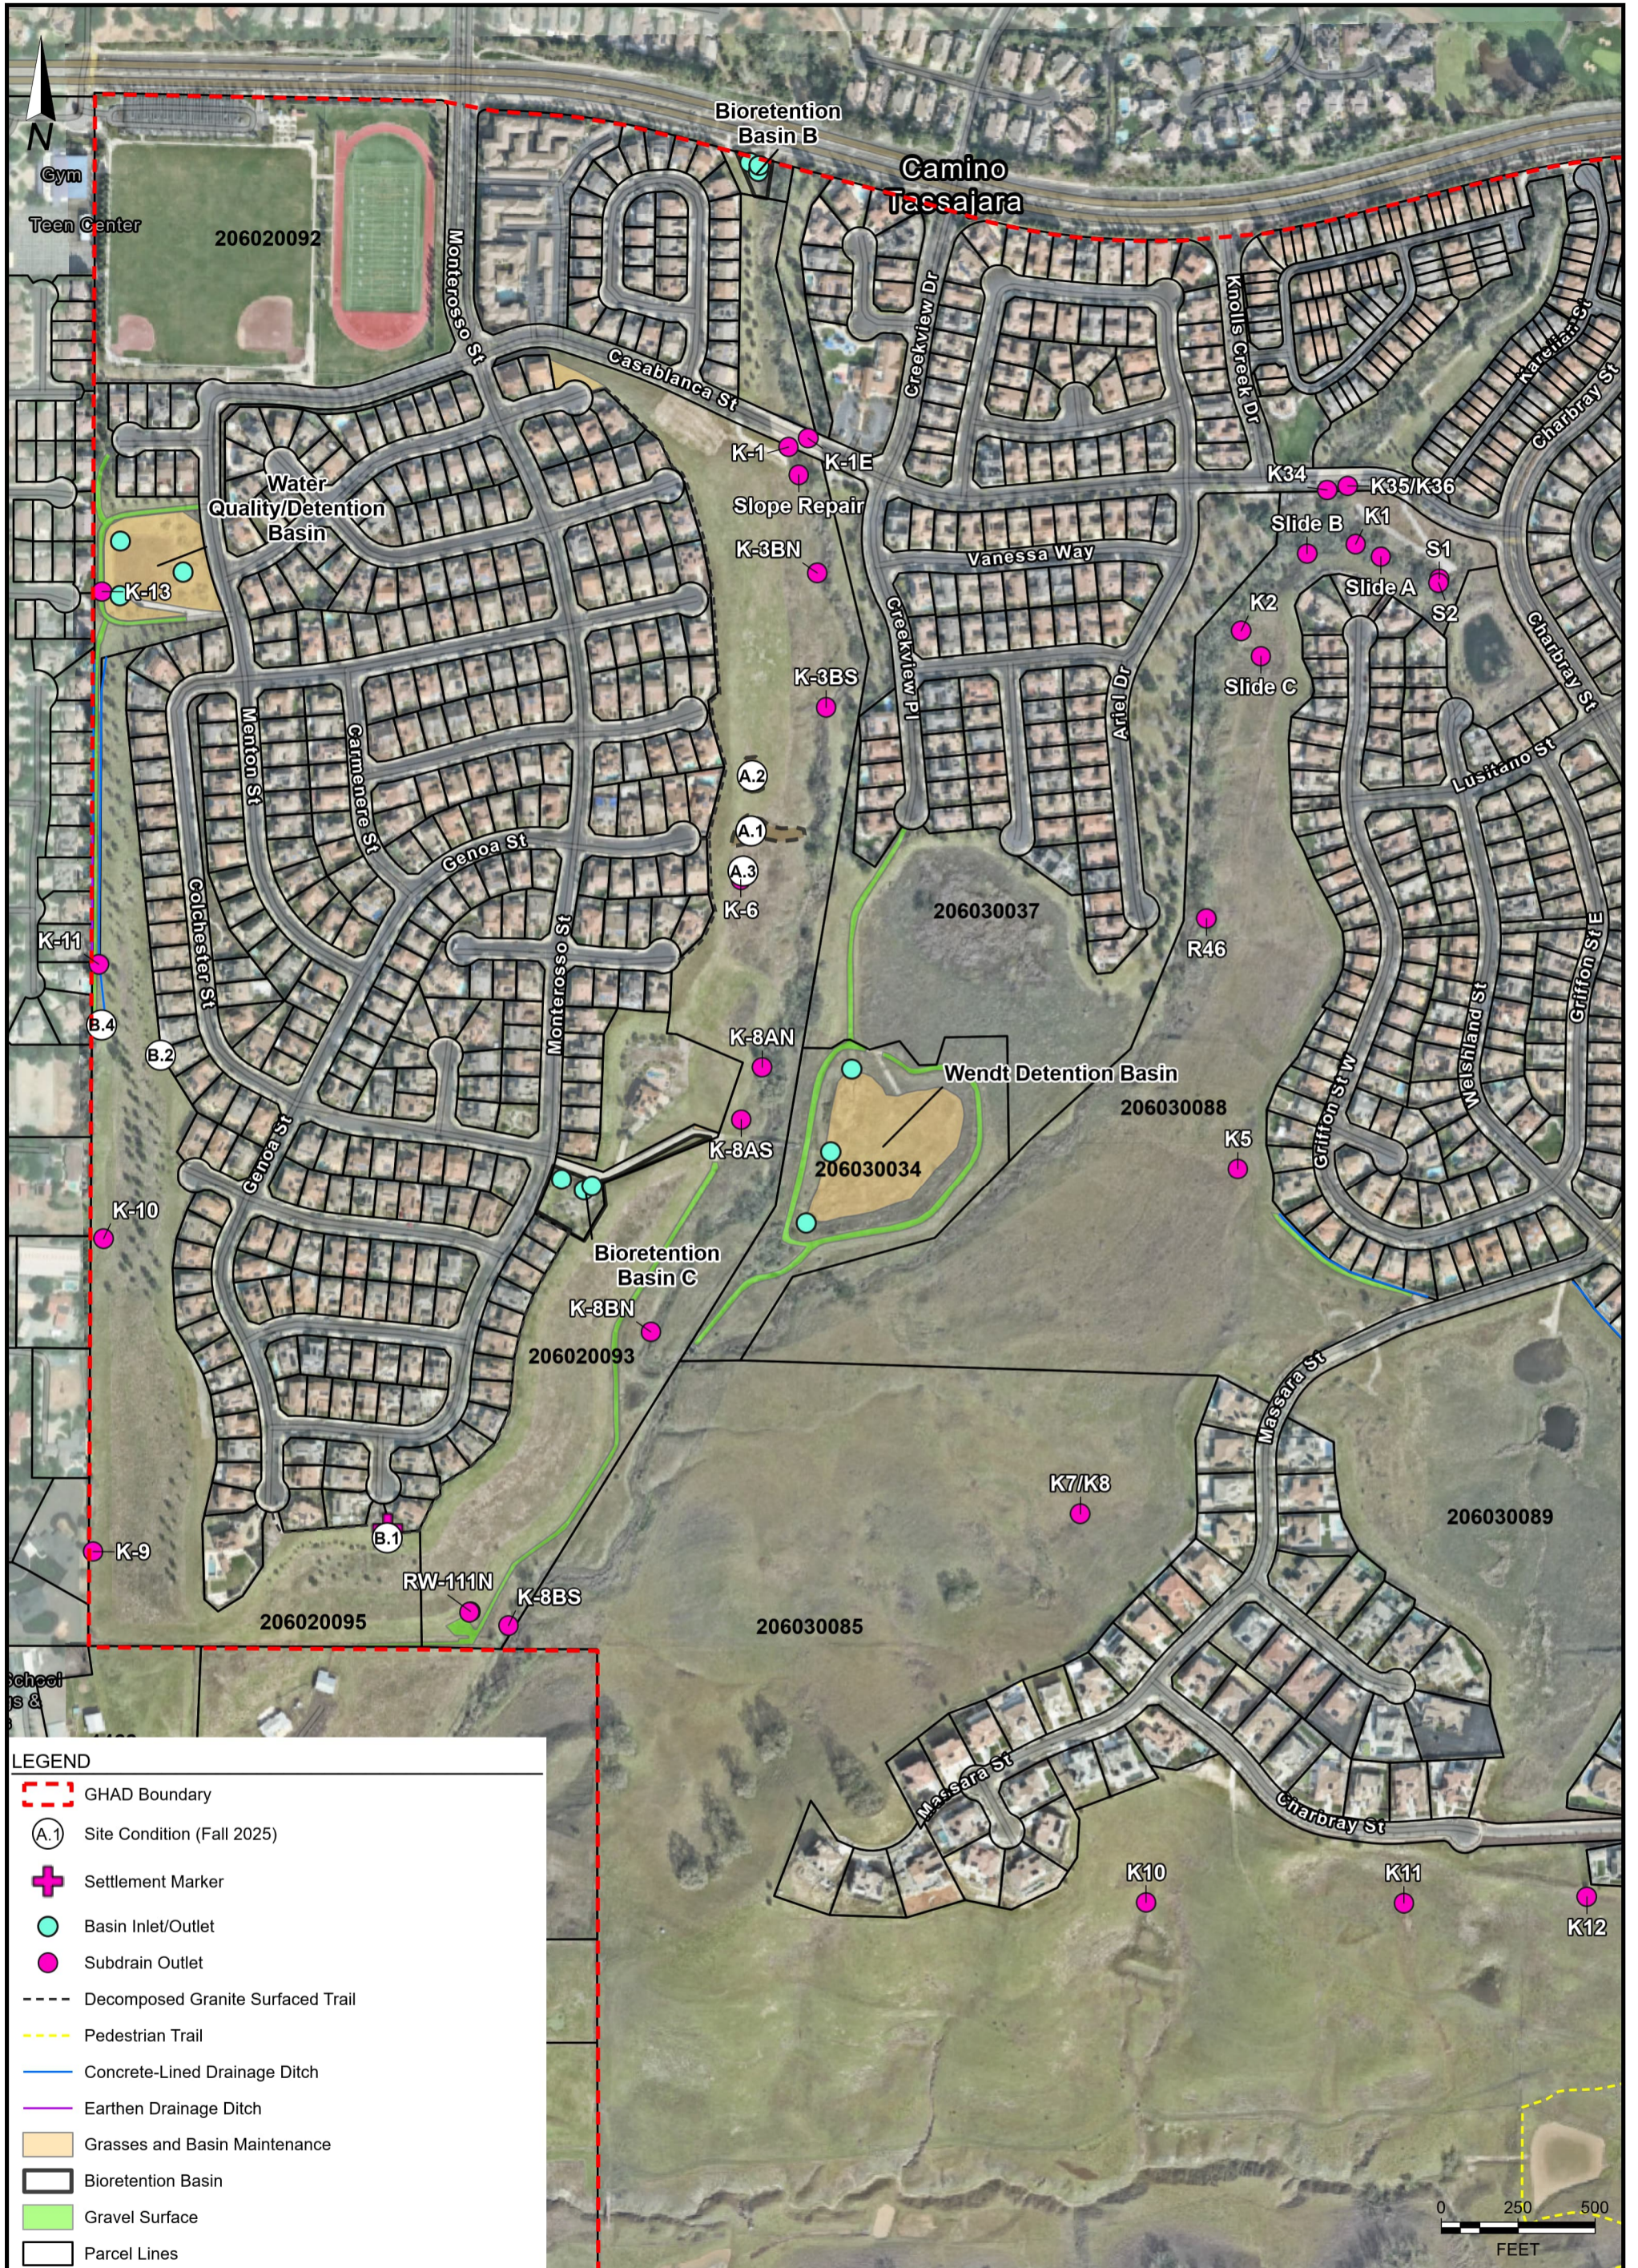
FIGURE NO.  
**1**

As first reported in the fall 2021 monitoring event, we observed distress and offset along the 3-foot-high masonry wall behind 1608 Colchester Street (Site Condition B.2, Appendix A, Figure 1). During our most recent monitoring event, we observed that the condition of the retaining

We first noted the distress of a masonry block retaining wall located at the base of the uphill slope along the western perimeter of the site during our spring 2024 monitoring event. During our fall 2025 monitoring event, we continued to observe settlement and offset of masonry blocks of the retaining wall and observed that the southern end of the retaining wall is leaning downslope at an angle of approximately 20 degrees (Site Condition B.4, Appendix A, Figure 1). The GHAD will continue to monitor this condition in future events.

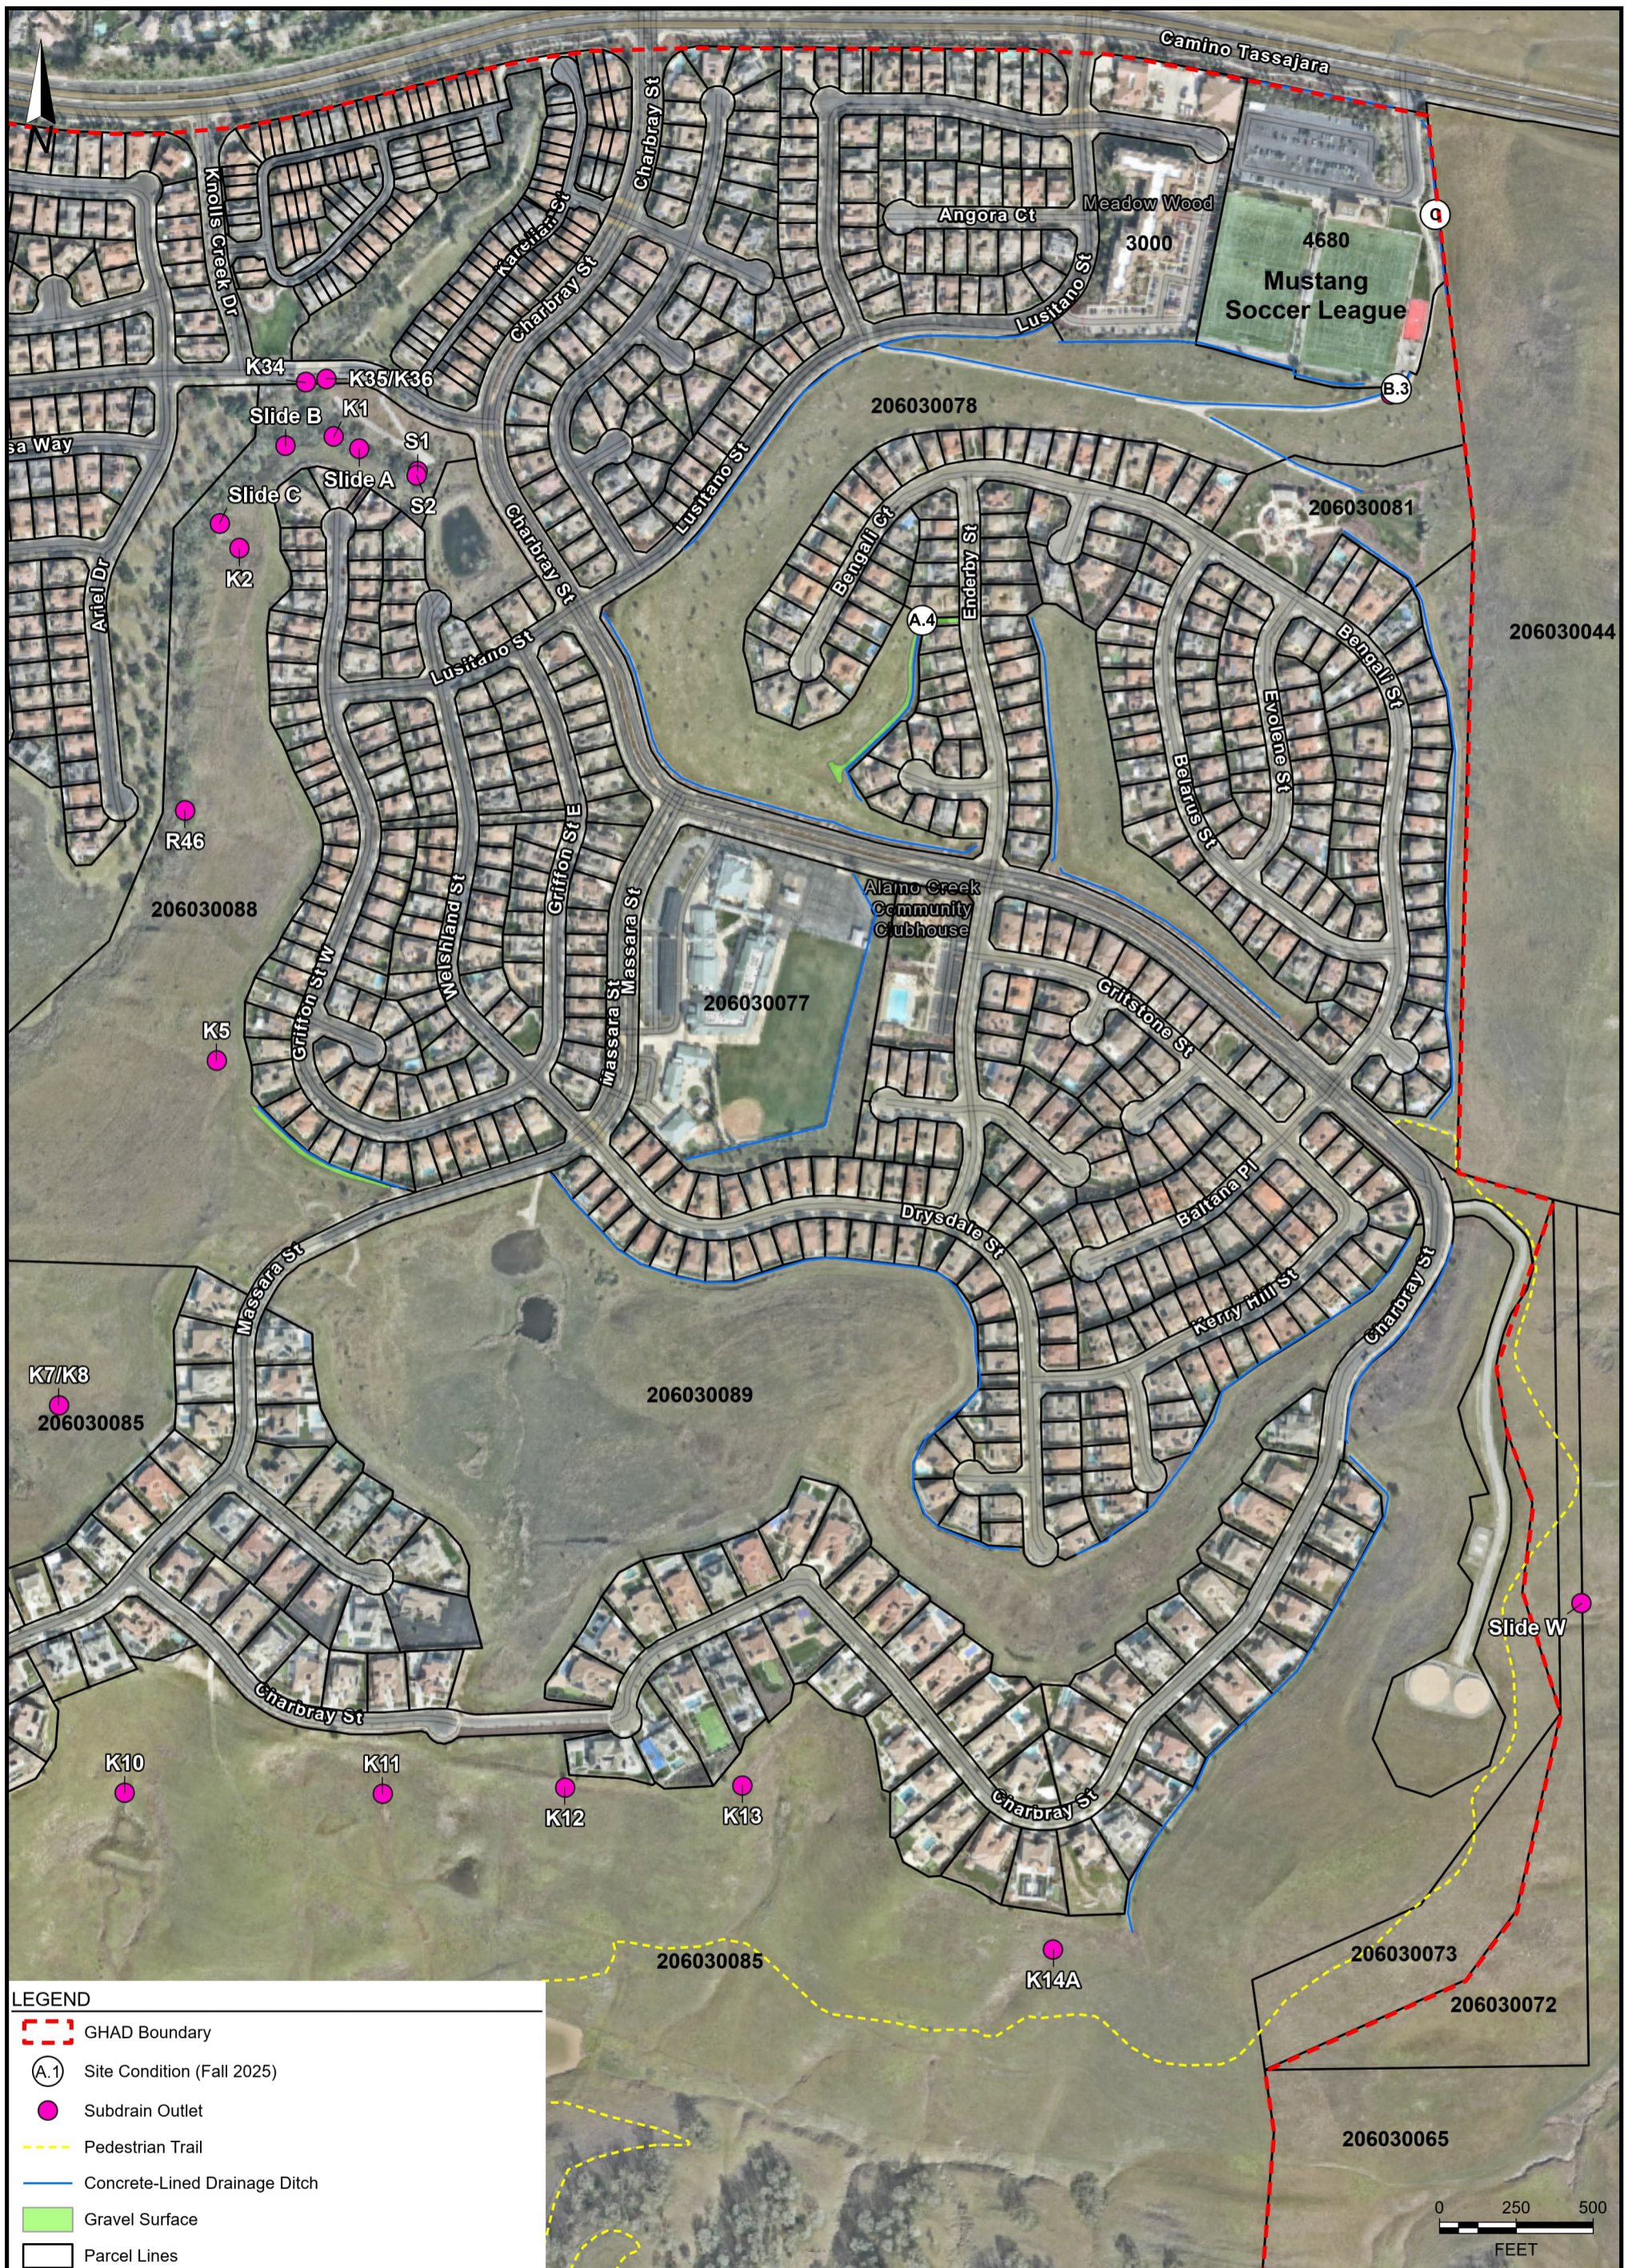
FIGURE NO.  
**2**

During our fall 2023 monitoring event, we observed erosion behind the MSE retaining wall on the southeastern boundary of the Mustang Soccer League fields (Site Condition B.3, Appendix A, Figure 2). The GHAD will continue to monitor this condition and consider placing engineered fill to provide design wall backfill height.
